Manhole Inspection Summary

Manhole # S13Q__003MH

Insp Date: **3/18/08 1:12 PM**

Location Address: **2804 Wlikens Ave**

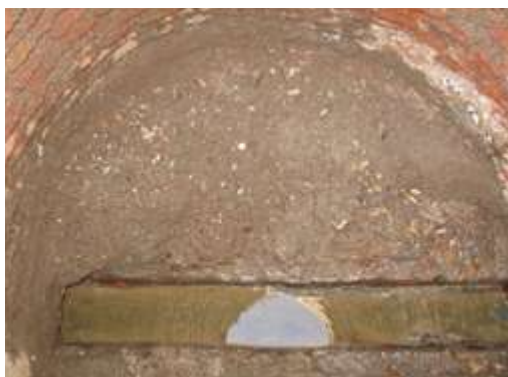
channel 2 to 2 1/2 of sediment..sand..needs cleaning.

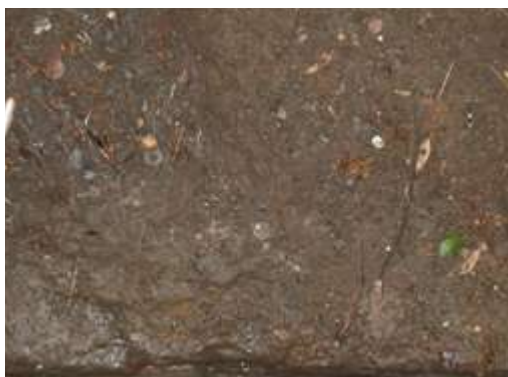
misc

bill up of sediament on bench

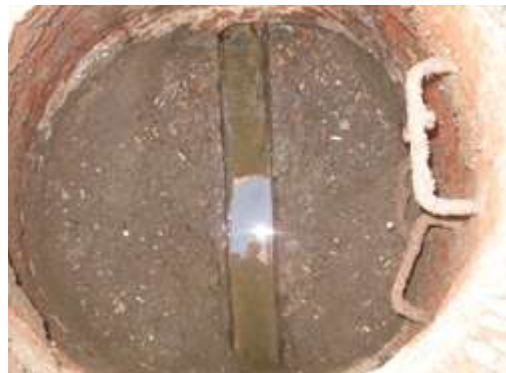
Top View

build up of sediment/ do o infiltration of chimney-frame joint also of line as well as flow through lid.

needs cleaning

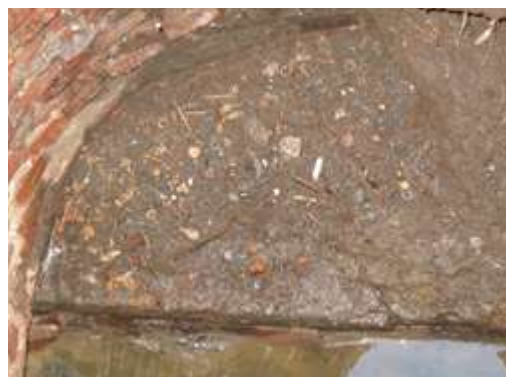
sediment build- up on bench

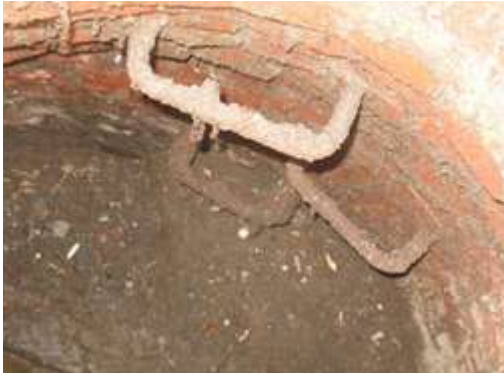
Defect 1

Infiltration: ☐ None ☐ Joint ☐ Cracks ☐ Mortar ☐ Roots ☒ **Wall**

infiltration in barrel

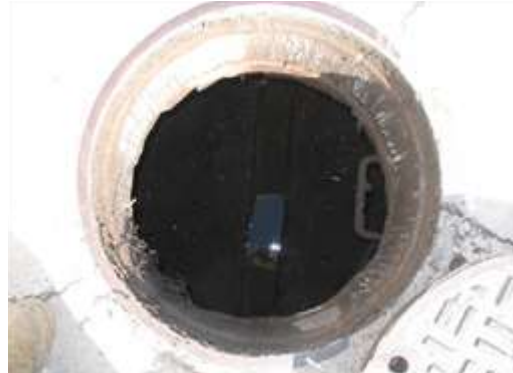
Defect 4

Frame Offset: **0** (in.) Condition: ☐ Sound ☐ Cracked ☒ **Leaks**

frame leaks-sheeting evidence

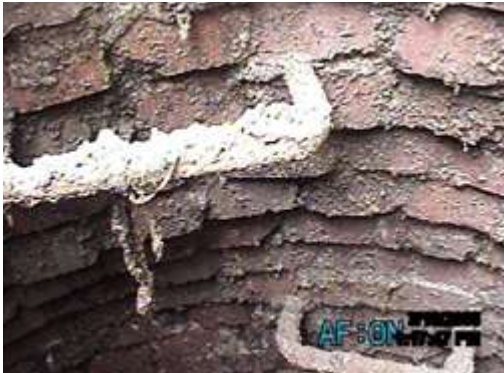
Defect 3

Infiltration: ☐ None ☐ Joint ☐ Cracks ☐ Mortar ☐ Roots ☒ **Wall**

Steps Count: **3** Missing: **0** ☒ **Corroded**

corbel infiltration at wall, corroded steps

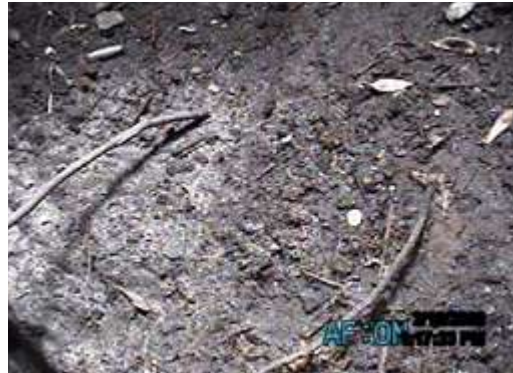
Defect 2

Condition: ☐ Sound ☐ Cracked ☐ Root Intrusion ☐ Deteriorated ☐ Leaks ☒ **Debris**

bench debris

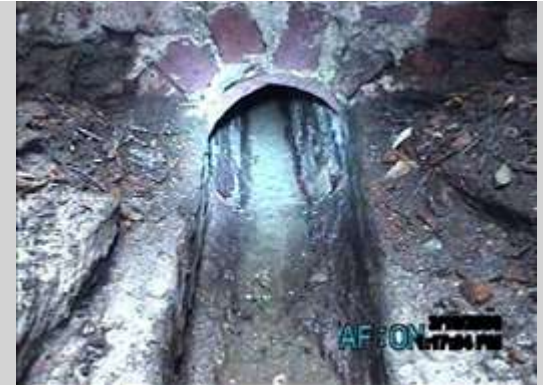
12 O'Clock Outflow

sediment in channel

Pipe Height: **8.4** (in.) Rod and Bar (Angled)
Pipe Material: **Clay** ☐ Pipe Lined
Invert Depth: **6.18** (ft.) Flow Characteristics: **Slow**
Deposits: ☐ None ☐ Mud ☒ Sludge ☒ Debris ☒ Grease
Silt Depth: **8** (in.) Deposits Extent: **Heavy**
Infiltration: **None** Pipe Seal Cond: **Sound**

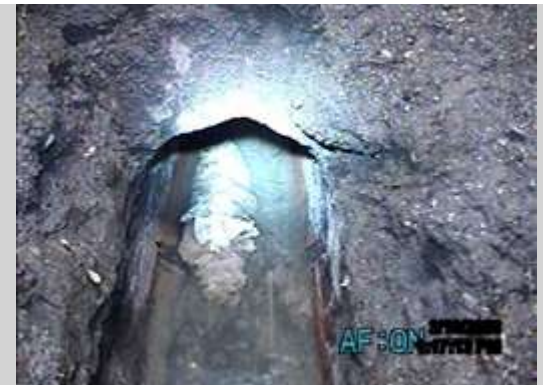
6 O'Clock Inflow

sediment and debris in channel

Pipe Height: **8.4** (in.) Rod and Bar (Angled)
Pipe Material: **Clay** ☐ Pipe Lined
Invert Depth: **6.20** (ft.) Flow Characteristics: **Slow**
Deposits: ☐ None ☒ Mud ☒ Sludge ☒ Debris ☐ Grease
Silt Depth: **8** (in.) Deposits Extent: **Heavy**
Infiltration: **None** Pipe Seal Cond: **Sound**
